## Amspect Inspections LLC / MO. Home Energy Audits

# Energy Audit

**Infrared Images and Blower door Depressurized**

**Sample Report.**

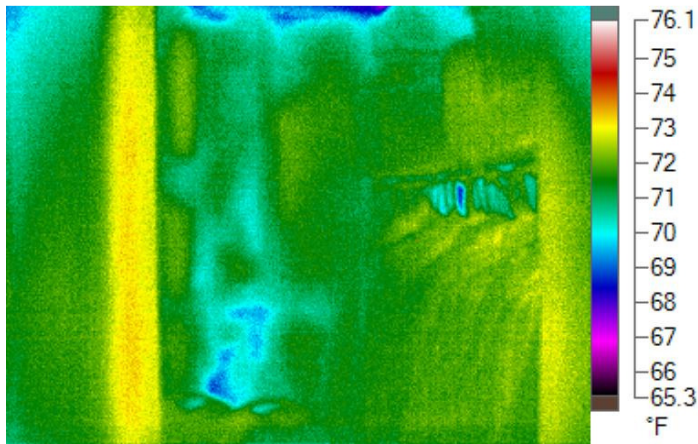
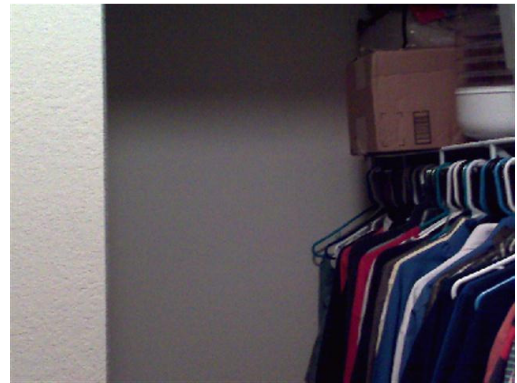
**IR000494.IS2**

Possibly improperly installed insulation and or rodent activity.

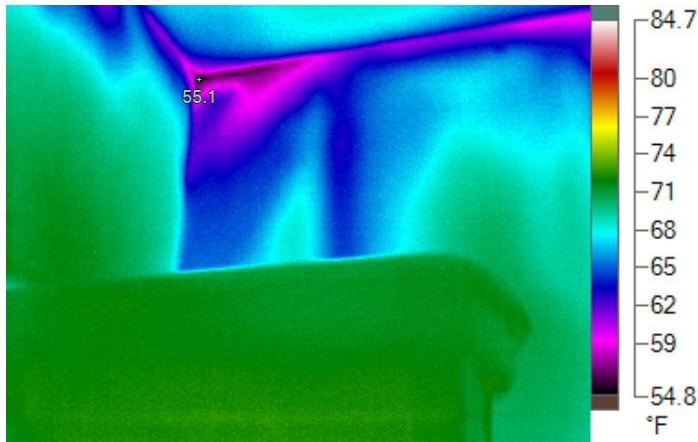
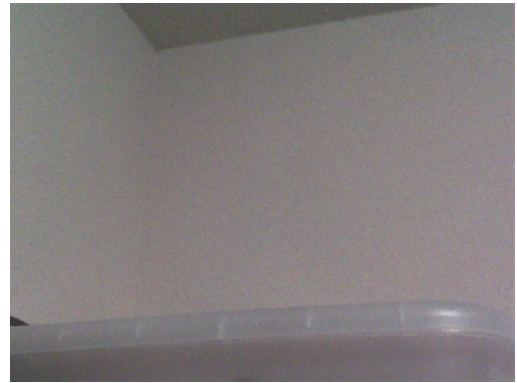
**IR000496.IS2**

Top plate air leakage.
